# Ford Focus - Pungent diesel smell

This 2008 Ford Focus 1.8 diesel with the KKDA engine had covered 110,000 miles, and it was overdue on a time basis for a new timing belt. The NCT was also due in the next three months, and I persuaded the owner to get the belt done now, to spread the cost before any possible NCT related expense would be needed.

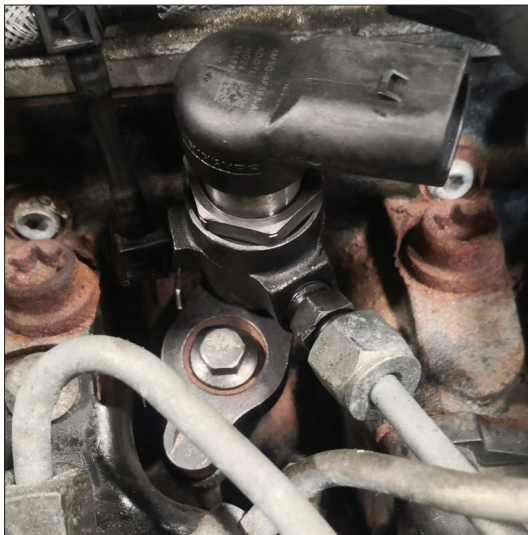
Once I lifted the bonnet, I realised that another problem also needed attending to. The pungent smell of diesel led me to the trail of the wet stuff coming from the area of the number three injector.

At first, I was under the impression that the problem was going to be the leak off connector and possibly only require a new O ring. Once I looked closer, I could see that the diesel was actually seeping from the body of the injector.

## The body of the fuel injector was leaking diesel

On these engines, the injectors don't need coding. With the old one coming out easily, this was not too difficult to rectify. Pushing the owners bill up with the cost of the injector was easily compensated for with the more pleasant driving environment, now lacking the pungent smell.
