Ford Transit - Juddering clutch problem

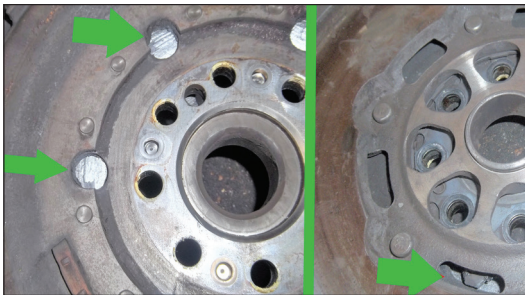
The rubber in the flywheel had deteriorated

Removing the gearbox and dropping the clutch down, I discovered that the Transit was fitted with a Dual Mass flywheel, but an early version which was more of a torsional vibration damper, and still required the clutch centre plate to have the springs built in to absorb the take up.

The flywheel was well and truly shot. It was the source of the drive problems, adding €200 to the price of the job, the owner was happy that the whole thing was turned round and back on the road within the day.
