# Ford Transit Connect - Failed Fuel Pipe

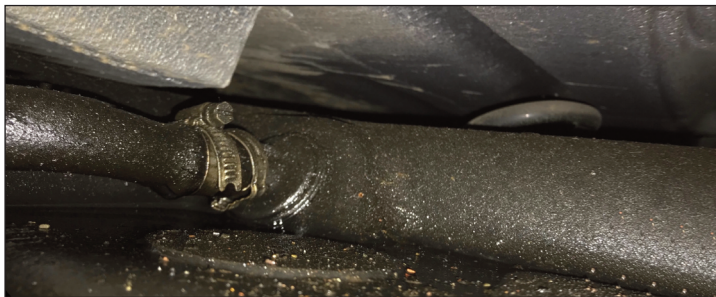
**The hose had been refitted before and was leaking where it connected to the fuel tank**

up on the ramp, we could see that the fuel appeared to be coming from the top of the tank. Upon closer inspection, we discovered that the top breather hose between the tank and the filler had failed.

This was good news for the owner, as it meant a repair could be made without having to source a new tank. When removing the old pipe, we could see that it had failed previously and been cut back and refitted. This time with a new pipe, the repair should be a bit more permanent.
