Hyundai i10 - Failed Washer Pump

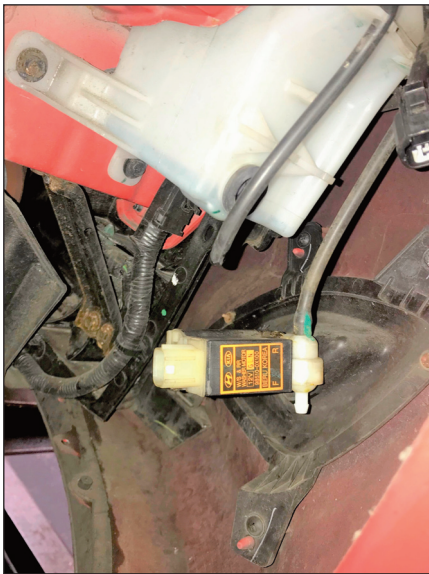
On this Hyundai, the reservoir is hidden behind the front bumper and the book time for this one is 2.7 hours. The front bumper cover needs to be removed to get access to the pump and so although this may be considered a small job, in reality it was not.

Access to the washer pump is not simple and makes the replacement time longer.

Using a test light I discovered that there was current going to the pump, but that this had failed. It is worth noting at this point that it is good to give the washers a spray at regular intervals, just to ensure that the pump and the fluid in the system gets moved occasionally.
