Opel Corsa - Oil Pressure Switch Causes a Leak

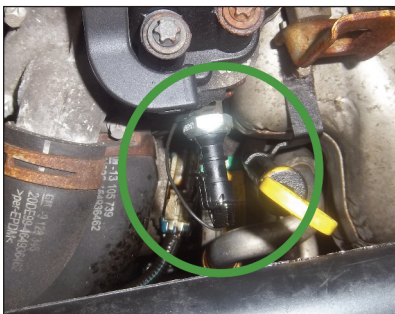
With the oil pressure switch replaced, the leak was halted.

The oil pressure switch had failed internally, and was allowing a steady flow of oil out through the centre of the switch. A new switch and a quick clean down of the area around and below the area soon had the oil usage back down to zero.
