Renault Scenic- Lower swivel change

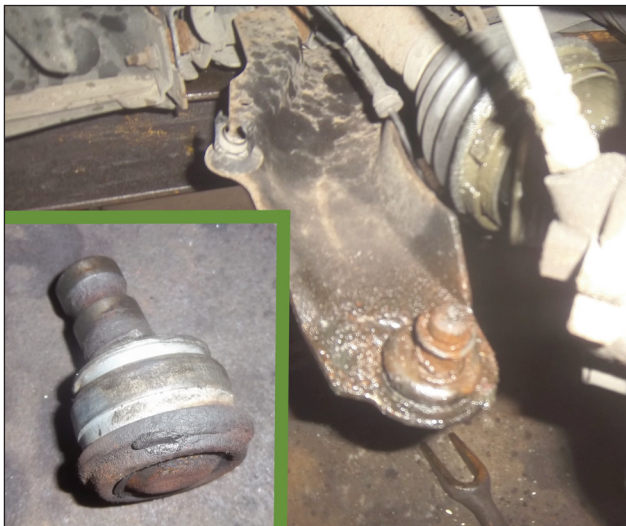
The lower swivel can be pressed out of the lower arm and the new one fitted without the need to remove the complete arm

This, of course, has the benefit that the lower arm bushes are also replaced at the same time. This 2007 Renault Scenic had extensive play in the lower swivel, and on this vehicle the lower arm is not particularly easy to remove. This is mainly because the bolt securing the front bush is hidden by an extension to the sub frame.

The swivel is available separately for around €15, and can be pressed out of the lower arm. This makes the job of replacing just the swivel a better option than replacing the complete lower arm.
