**The fault was not in the vehicle but owner's accessory**

## Toyota Yaris - Lighter problem

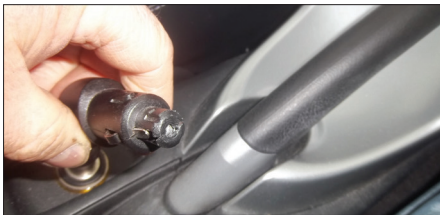
The 15-amp fuse for the lighter circuit was in good condition, so the next step was to plug in my own test light to check the connection. The light illuminated proving that the outlet was all in good order. The mystery was solved when I inspected the owner's adaptor that was being used. This had collapsed, and was in fact the source of the trouble.
