Fiat

Ducato 2.3 TD 2006> - Clutch Kit HK2194

CLTB 0013

HK2194 TRANSPORT SPACER

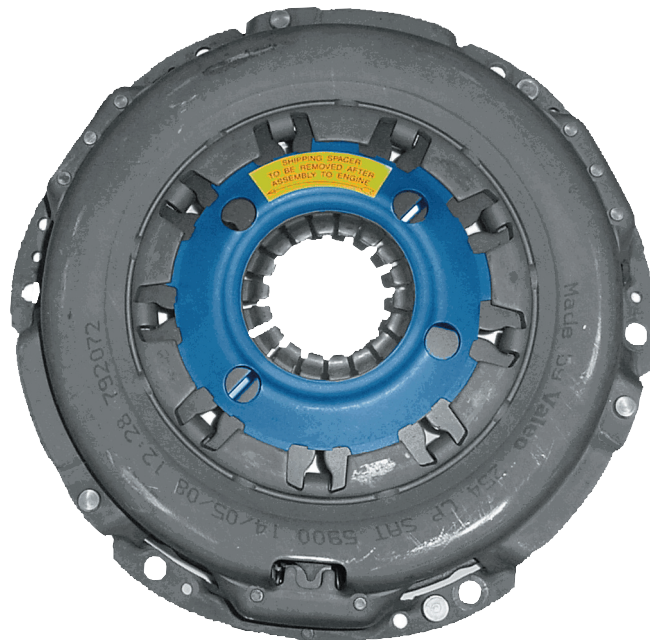
Concerns; Failure to remove the transport spacer before refitting the gearbox to the back of the engine can result in major component failure.

The transit spacer is highlighted in blue for illustrative purposes only

Method; With the transit spacer in place fit the cover assembly and driven plate to the flywheel using a suitable alignment tool for the driven plate.

When bolted up to the flywheel the spacer will become loose and can be revolved anti-clockwise until the tags are in line with the slots/spaces in the cover pressing.

When the tags and slots are aligned the spacer can then be removed.

The gearbox can then be re-fitted to the back of the engine.
