Volvo V70 D5 SE - Noisy Handbrake

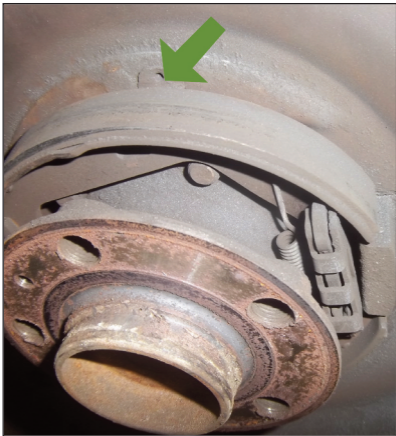
The retaining clips had broken away, allowing the shoes to fall out of place and rub the inside of the drum

After removing the rear brake calliper and then the brake disc, we could see that the handbrake shoes had broken away from the retaining springs, allowing them to fall outwards and rub against the inside of the disc/drum.

Although slight wear had taken place within the drum, fitting a new pair of retainers to the shoes and cleaning everything up resulted in a more than satisfactory handbrake operation.
