Renault Clio - Weak Windscreen Washer

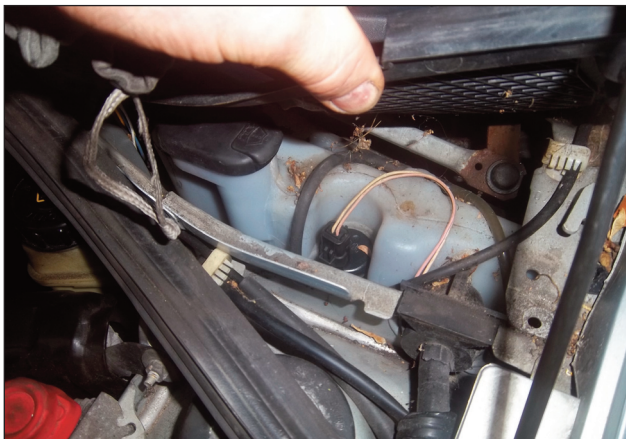
This meant that it wasn't the washer jets at fault, but a weak washer pump. On this Clio, unlike many modern vehicles, the washer pump

The washer pump on this Clio is easily accessed by unclipping and lifting up the plastic front scuttle panel.

is easily accessed from the rear of the engine bay under the scuttle panel.

With the washer bottle cleaned out and a new pump fitted, the screen wash was replenished and the washers tested. They now emitted a good jet of fluid across the windscreen.
