Mercedes C-Class - Coolant leak from Intake Manifold

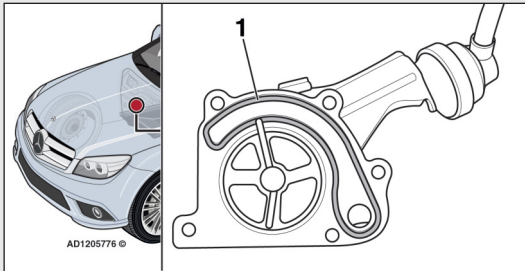
Answer: We are aware of a coolant leak issue in the area of the intake manifold on Mercedes-Benz models, with a 651 engine code. The coolant leak is due to a faulty EGR cooler bypass valve seal. Fit a modified seal,

available from Mercedes-Benz parts department, to the EGR cooler bypass valve Fig.1.1. This should rectify the fault. Ensure engine coolant level and anti-freeze content are correct.
