Blue Print ADP152207

To fit:
various Citroën, DS, Fiat, Mitsubishi, Peugeot and Toyota models

Engine: 1.4 and 1.6 diesel

Air filter

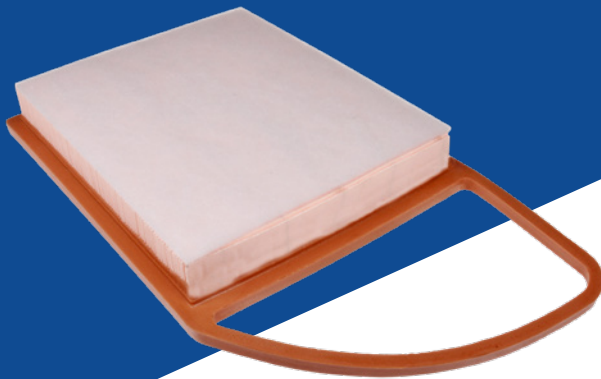
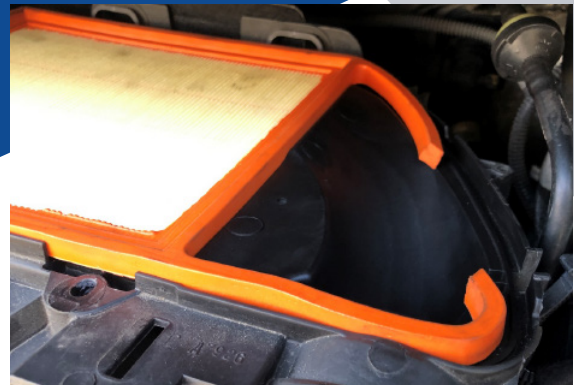
Figure.1

When replacing the air filter element in the vehicles listed above, care must be taken to make sure the foam seal of the filter element is installed correctly into the air filter housing. An incorrect installation can result in the foam seal being damaged or cut by the upper part of the filter housing during assembly. Damaged or cut parts of the seal can be ingested into the engine, resulting in engine damage. (Fig.1)

The foam seal loop of the air filter element, which seals the air intake section of the housing, can be distorted or misaligned during installation.
