Technical Bulletin

Product Information: **ADG06290** Manifold Repair Kit

Applications: Daewoo/Chevrolet Matiz 800cc

Date Issued: 07/2011

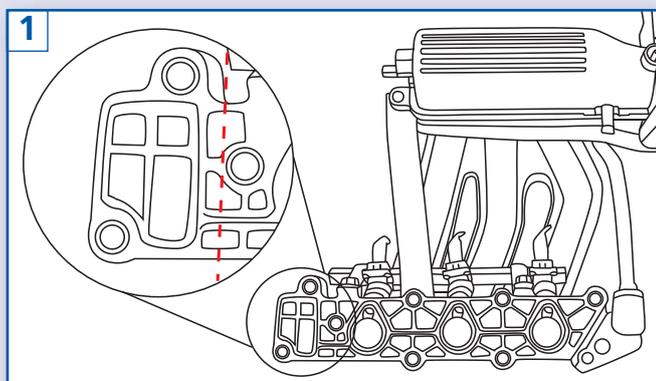
A common problem on the 800cc Daewoo/Chevrolet Matiz is corrosion to the alloy cylinder head and distortion (Warping) of the plastic inlet manifold, resulting in a coolant leak between the two. The plastic inlet manifold on this three cylinder engine includes a 'blanking plate' moulded to the end which seals against a water-way on the cylinder head. Over time the plastic deteriorates, eventually resulting in a coolant leak. ADG06290 is an inlet manifold repair kit to give a long term cure to this particular problem, comprising of a high quality blanking plate and modified manifold gasket. Carrying out the modification is straightforward and is illustrated below.
