Technical Bulletin

BMW MINI Radiator Fan Resistor Replacement Applicable References: ADB111402

Applications: BMW MINI 1.6i 2003>2006

Date Issued: 09/2012

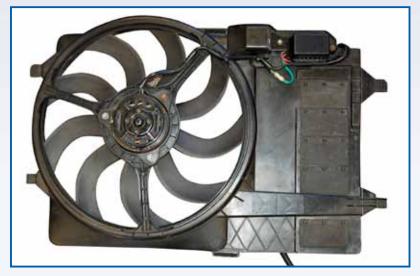
Using the supplied heat shrink butt connectors, connect the following wires together (Figure 5):

- The **solid red wire** of the new resistor to the larger of the two red wires of the original harness.
- The **red wire with black stripe** of the new resistor to the smaller of the two red wires of the original harness.
- The **green wire** of the new resistor to the blue wire of the original harness
- Once firmly crimped, apply heat to the connectors to activate the heat shrink and form a waterproof connection. (Figure 6)
- Fit the resistor's cover and tighten the two 8mm screws. (Figure 7)
- Refit the fan assembly to the vehicle.
