Technical Bulletin

ADC48226 Front Wheel Bearing

Subject – Application Guide

Vehicle - Mitsubishi Shogun & Pajero models 2000>

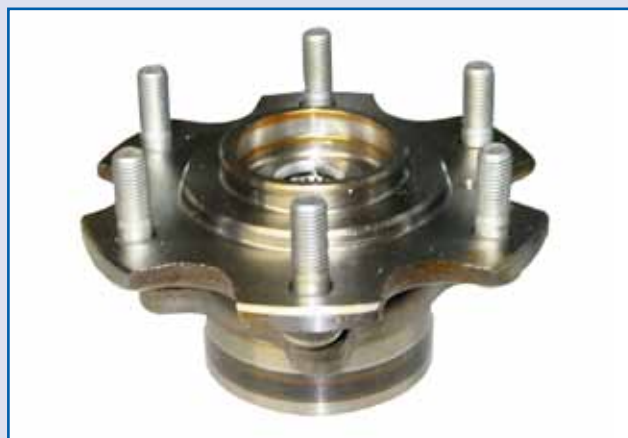
1. Fit the washer on the Hub assembly, with the washer's chamfered face towards the castle nut.

See Image (on right).

Correct position of washer

2. Tighten the castle nut to 200 ± 10 Nm.

When fitting the Hub assembly, care must be taken NOT to allow the vehicle weight to be placed onto the Hub assembly before tightening the castle nut. Doing so will result in the bearing being damaged.
