# Technical Bulletin

## ADT36846C Suction Control Valves Date Issued: 1/02/2011

## 2003 Toyota RAV4 2.0D-4D engine compartment

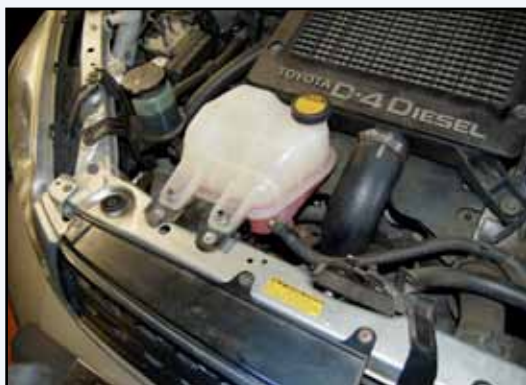
- Unbolt the radiator expansion bottle (2 nuts) and move it to one side to gain access to the fuel pump. (You may wish to disconnect the upper hose and plug it to give you more room.)
- Remove the air intake/intercooler pipe.

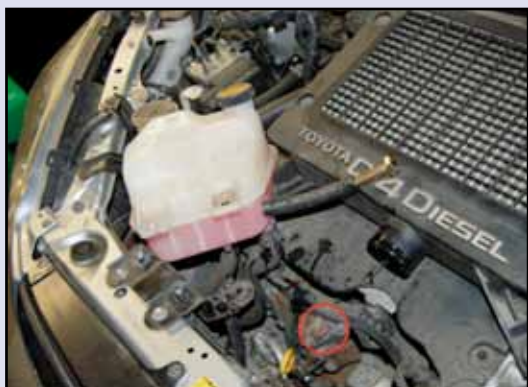
- The fuel pump is now visible (just to the left of the starter motor). Make sure the area around the green and red SCV's is as clean as possible to reduce the risk of debris entering the pump.
- Disconnect the wiring connectors from the SCV's.

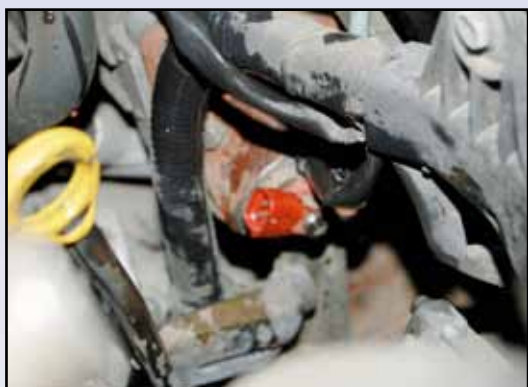
- Remove the four SCV mounting bolts (two per valve) and then remove the two valves from the pump making sure you note the positions of the red and green valves. (red at the front)
- Although the seals on the new valves are pre-lubricated, it is good practice to apply a little engine oil to the seals to reduce the risk of damage during fitting.

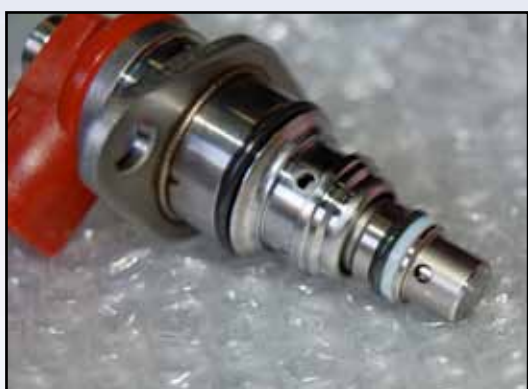
- Ensuring the mounting area is clean, install the valves carefully making sure that they are installed in their correct positions and that the valve flange fits flush to the pump before tightening the fixing bolts to 13Nm (10lb-ft).
- The rest of the fitting procedure is the reverse of the removal.
- Reset the engine diagnostic trouble codes using a suitable diagnostics tool (or by removing the ECU fuse for a couple of minutes) before road testing vehicle.
