Blue Print ADT36853

Toyota Avensis, Corolla 2.0 D4d

Suction Control Valve

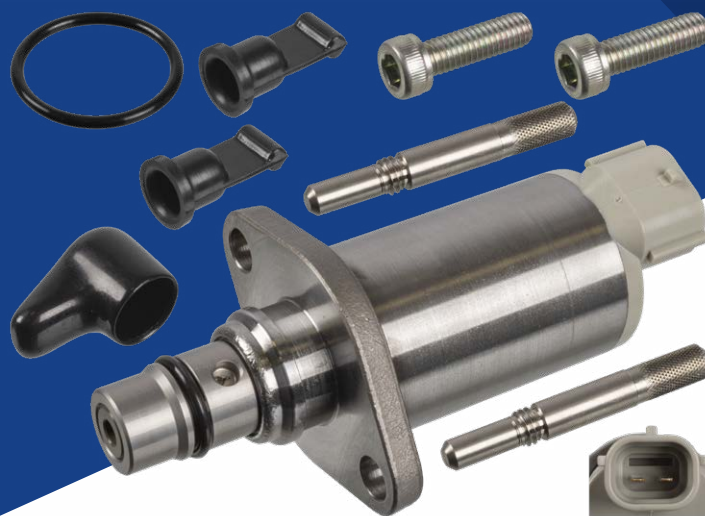
Engine surging, erratic idle, and a sudden lack of power which can be intermittent. Engine fault codes logged relating to fuel rail pressure deviation.

The Suction Control Valve (SCV) solenoid has extremely fine tolerances within its moving parts, which are quickly affected by dirt and/or contaminated fuel.

A worn or contaminated SCV will cause the high-pressure fuel pump to deliver an inconsistent fuel pressure compared to what is being requested by the Engine Control Unit (ECU). Inconsistent fuel pressure at the injectors can cause surging as the ECU attempts to find the correct operating fuel pressure.

Check the fuel system for contamination and replace the fuel filter and suction control valve.

Remove the SCV, noting the connector position of the SCV to the pump. Loosen bolts and remove. Then remove the large O-ring.

Install the new large O-ring to the fuel pump. Then, screw the two new guide pins into the mounting holes and apply engine oil to the small O-ring located on the SCV before fitting to the pump.

Install the SCV by carefully pushing it into the housing. When the SCV is in position, remove the guide pins, fit the new bolts, and tighten them according to the manufacturer's tightening torque.

Once the installation is complete, carry out the supply pump learning procedure and perform a high-pressure pump test using a suitable diagnostic tool to confirm that there are no leaks and that the fuel system is performing correctly.
