Citroen/Peugeot rear brake disc installation

The gap between the wheel speed sensor and the sensing ring on a brake disc is very important to the correct operation of the ABS or other steering control systems. Borg & Beck detail what is needed in Citroën/Peugeot models to carry out a successful service and assure that the ABS will still function as intended.

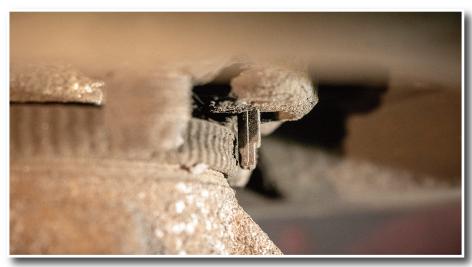
If once a new disc has been installed you can see that the ABS sensor is contacting the magnetic reader, or the gap is not aligned correctly, then the disc and ABS sensor should

The wheel speed sensors must be aligned with the disc and have a clean, clear gap of 1-2mm (as shown above) to function properly

be removed, taking care not to damage the ABS sensor. Once removed, clean the rust and corrosion from the ABS sensor seating location. When sufficiently cleaned and correctly seated, with the disc re-installed,

you will be able to see a clear 1-2mm gap.

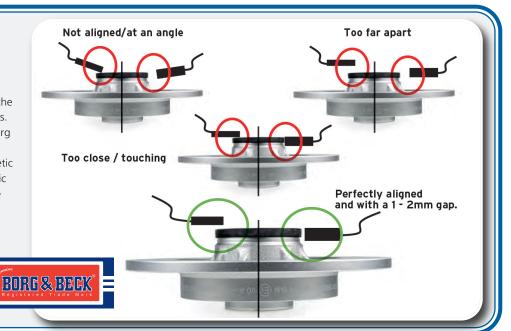
each position.

Below you can see two examples of ABS sensors located in different positions, however the principle remains the same for

Sensor Alignment When replacing any disc, it is strongly recommended that both rear disc hubs are replaced at

To avoid damage to the magnetic encoder, keep it away from magnetic fields. The plastic cap protecting the seal should only be removed just before fitment.
