MINI THERMOSTAT REDESIGN TO OVERCOME OVERHEATING ISSUES

Issue Date: 23/09/19 Issue Number: COTB0027B

APPLICATION : MINI R55, R56, R57, R58, R59, R60, R61

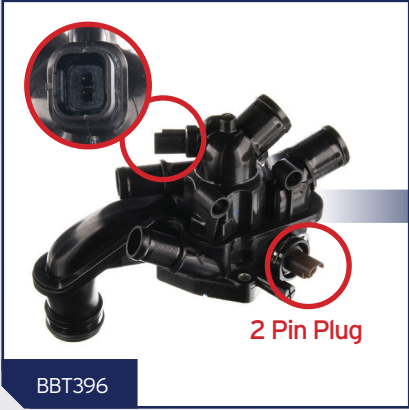
<p>BBT396</p>

Due to an increase in overheating issues & symptoms such as an erratic temperature gauge, erratic running, radiator fan run-on, or poor heater function in the above vehicles, the O.E.M. have modified the design of the Thermostat housing. Following the O.E. specification, we have replaced the old design BBT396 with the new latest design BBT487. The latest design benefits from an electronically controlled thermostat, a reinforced structure, and a new configuration of sensors.

OLD DESIGN	NEW DESIGN

If your vehicle has the BBT396 or equivalent, then it is recommended that this is replaced with the updated version BBT487. It is advised that following replacement of these components, the software is checked and re-programmed / flashed to ensure that it is operating with the latest version.

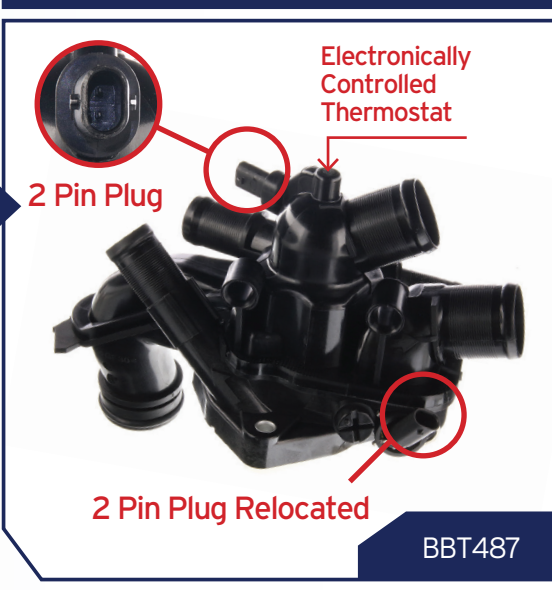
<p>BBT487</p>

We have highlighted the key differences below so that you are clear that the latest part, although visually different to what may be on the vehicle, is in fact the correct product.

The modified version has had the lower 2 Pin connector relocated, therefore, a new cable may also be required to carry out the modification.

New Cable: BTS3092 - Thermostat Wiring Harness
