ContiTech

CT 979K3 timing belt kit for Ford/Volvo 2.5 I Various models from 2004 onwards

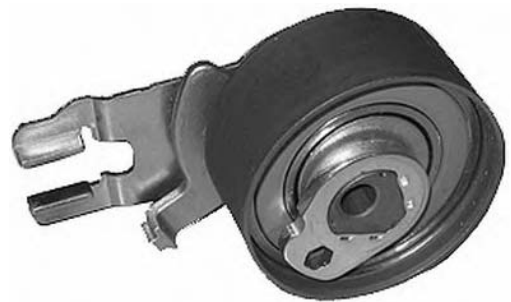
Fig. 1
Previous pulley design

The tensioning pulley supplied in the kit has a different design to the pulley installed up till now in the vehicle. (Hex key used to adjust eccentric until pointer is aligned)
