# Eure!Car Tech Blog

## Audi idle and BMW display

### **BMW E39 Fault on instrument panel display**

### **Audi A4 and A5 Idle control malfunction**

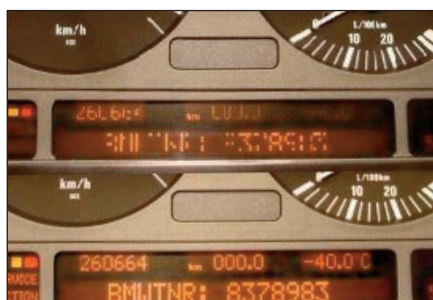
A certain number of pixels are not lit, which makes it difficult to read the messages.

Progressive deterioration of the display or a communication fault with the instrument panel main board.

First, it must be ensured that the display is communicating correctly with the main board, check the continuity of the connector solder joints.

As a general rule, the fault usually lies in the component itself.

We resolve this problem by repairing the connections and replacing the display.

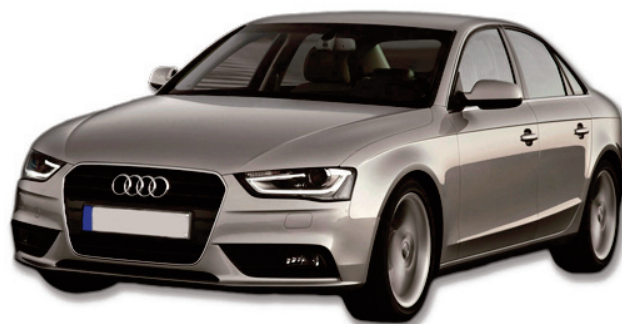
Fault code P0505 (generic code "P") or 2252 (hexadecimal) with the description: Idle control malfunction.

Software malfunction in the gearbox control unit.

Read the fault codes in the gearbox control unit with the diagnostic tool and check that code P0505 or fault code 2252 is recorded.

Clear the fault codes from the gearbox control unit and check that code P0505 or 2252 is recorded again.

Reprogramme the gearbox control unit software with the corresponding software at origin.
