Technical Bulletin

Premature Failure of Accessory Drive Belts

GATES REFERENCE :	All V-and Micro-V® XF belts
MAKE :	
MODEL :	
ENGINE :	
ENGINE CODE :

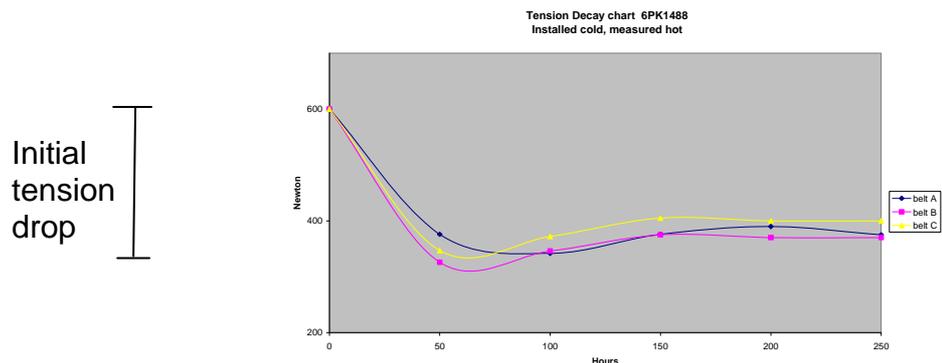
Fig. 1

As there is no automatic tensioner to control the tension of the belt over its expected lifetime, the installation tension on fixed systems has to take into account the initial tension drop over the first days of functioning on the drive (Fig. 1).

It is very important that this initial tension setting is correct, in order to prevent premature wear/noise/failure.

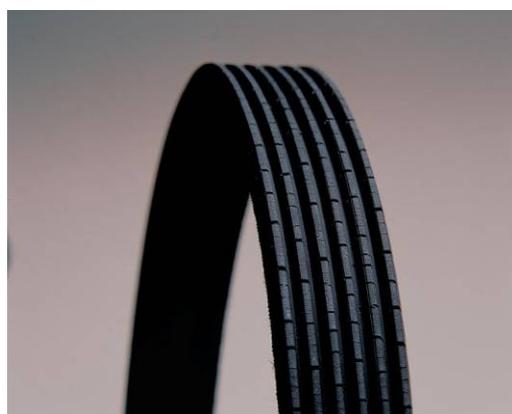
Fig. 2

- Too high tension will lead to abnormal wear, extreme heat build up, rubber hardening and cracks (Fig. 2), premature cord break and noise.
- Too low tension will lead to slippage (insufficient tension to drive the different components), noise, extreme heat build-up, rubber hardening/cracks, belt rupture and pulley wear. Belts which have been slipping will show shiny flanks, on both sides of the belt/rib (Fig. 3).

Recommended static installation tension:

New belt	Used belt
AV10	350N (35 Kg)	270N (27 Kg)
AV13	500N (50 Kg)	350N (35 Kg)
Micro-V [®] XF	100N (10 Kg) / rib	60N (6 Kg) / rib

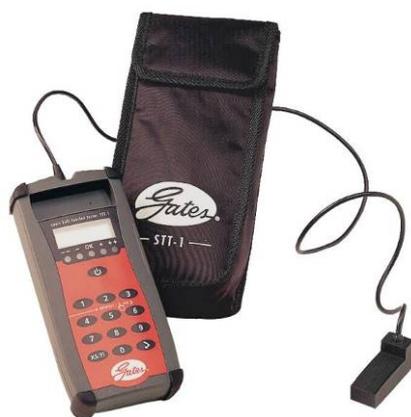
Fig. 6

- Kriket I (7401-00071) (Fig. 4) is ideal for measuring the tension of V-belts, this tool can also handle narrow Micro-V[®] XF belts
- Kriket II (7401-00072) (Fig. 5) is a simple tool for measuring tension of wider Micro-V[®] XF belts.
- However, for vehicles with a more sophisticated drive on modern engines, Gates offers the Sonic Tension Tester STT-1 (7420-00301) (Fig. 6), which was initially developed for checking the tension of Timing Belts. This very accurate tool can also be used for checking the tension of all Micro-V[®] XF belts tensioned with a manual tensioner. It allows to make a distinction between new and used (run in) belts.

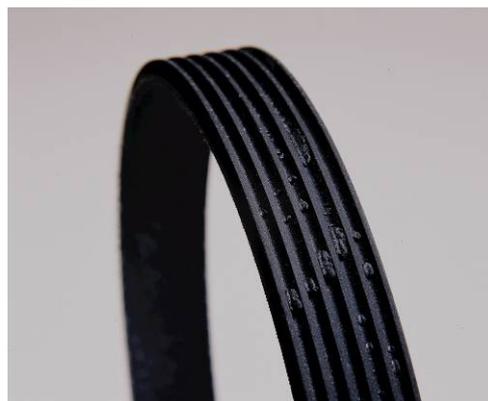
Fig. 7

- Pilling:
As the ribs do not enter perfectly into the pulley grooves, particles of rubber are worn away from the rib sides. These particles are pushed together in the belt grooves, forming little rubber balls which will create noise (Fig. 7).
- Damaged outside ribs:
The outside rib which is running into the pulley flange gets damaged and can come loose (Fig. 8). Also the tensile cord could be pulled out of the belt. These loose ribs/cords create a very dangerous situation: they could enter into the timing belt system resulting in an engine breakdown.
- Noise:
The ribs not entering straight into the pulley grooves can lead to belt noise.

If misalignment is the problem, our DriveAlign® laser (7468-00113) (Fig. 9) will allow you to determine which pulley is misaligned.

It is clear the alignment problem should be solved before installing a new Micro-V® XF belt!

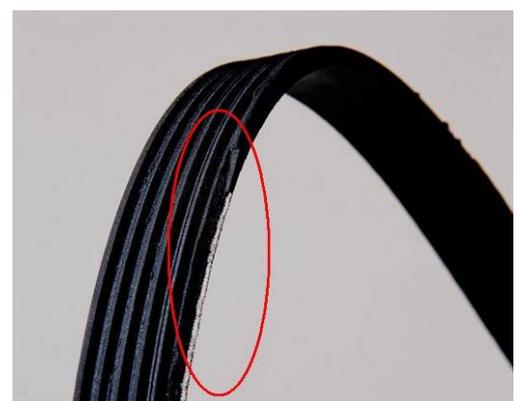
Fig. 8

Belts which have been running under misalignment will have a shiny aspect on one side of the ribs.

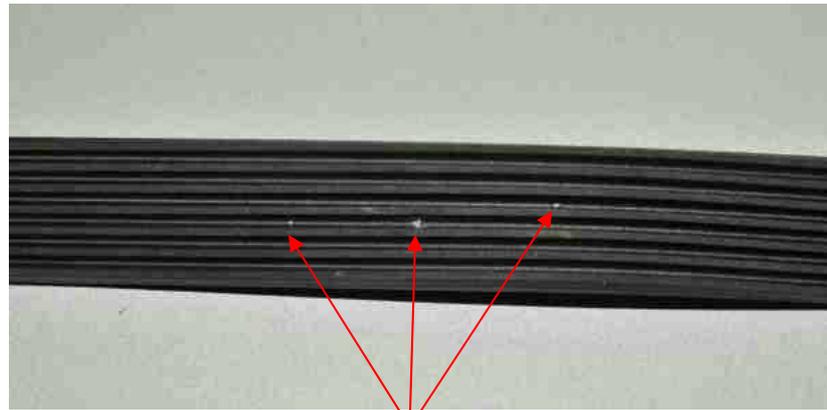
Fig. 10

Little stones in between the belt ribs (Fig. 10) can be another reason for noise. These can be found via a visual inspection.
