## Alfa 156 All models

### Fuse box cover comes loose.

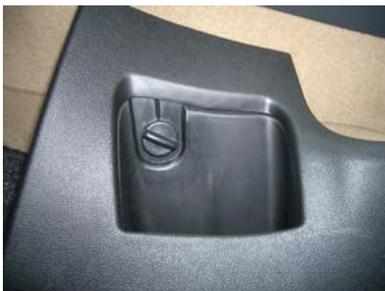
Fig. 1

If there are complaints with this vehicle that the fuse box cover comes loose, one possible cause is the lack of tension force of the retaining clips. To eliminate the problem, a modified cover with a retaining screw (Fig. 1) must be installed. To do this proceed as follows:

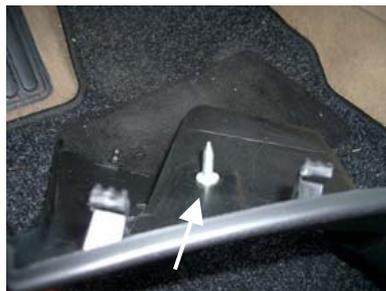
Fig. 2

Screw with  
plastic washer

- Remove the old cover.
- Remove the plastic washer from the retaining screw of the new cover and pull the screw out (Fig. 2).
- Install the cover and mark the dashboard through the hole for the retaining screw.
- Take the cover off again and drill an 8 mm hole at the spot marked on the dashboard.
- Attach a metal clip with thread above the bore hole (Fig. 3).
- Insert the retaining screw and plastic washer back into the cover and install the cover.
- Tighten the retaining screw.

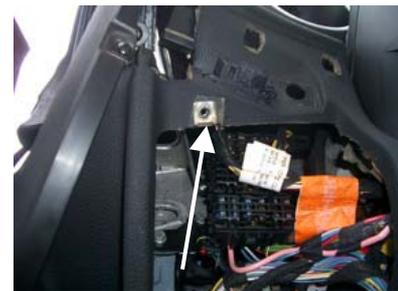
Fig. 3

Metal clip  
with thread
