# BULLETIN

## Vauxhall

**Insufficient engine power malfunction  
indicator lamp illuminates sporadically**

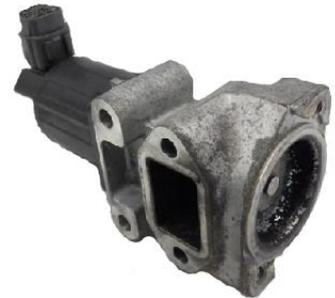
Figure 1

The cause of the aforementioned problem can be a dirty EGR valve (exhaust gas recirculation valve) (figure 1 / 2) and/or an EGR channel that is blocked with impurities (figure 3) in the intake manifold.

- Release the plug connection and remove the EGR valve
- Check the EGR valve and replace if necessary
- Remove the intake manifold
- Check EGR channels for impurities and clean if necessary (use a suitable tool)
- Install the intake manifold
- Carry out a test drive
- Read the faults using a diagnostic unit and delete them if necessary
