Audi, Seat, Skoda, VW From model year 1997

Coolant pump: noises, failure

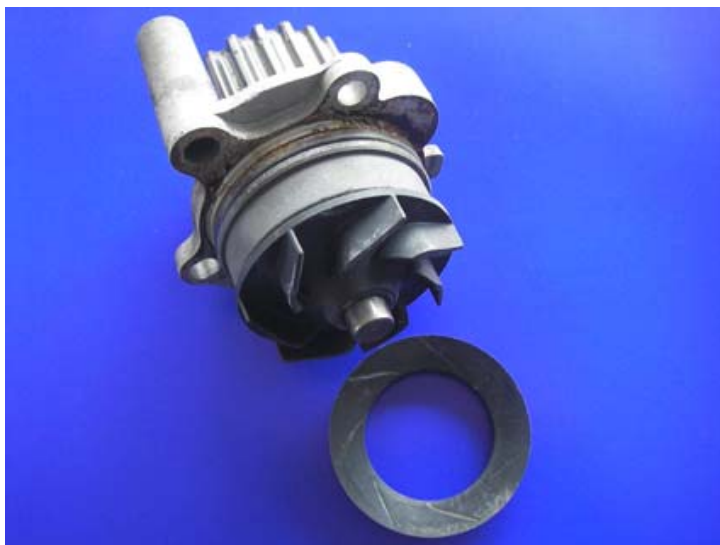
There can be noise development and/or failure of the coolant pump with diverse models and engines of the above-mentioned vehicles. Noises are caused by the impeller, which is often made of plastic, coming loose off the shaft. There are also cases known where parts of the impeller have broken off (see photo). This leads to a reduction in cooling capacity and can lead to the engine overheating. Ignoring the noises can lead to engine damage. A faulty, completely destroyed bearing in the coolant pump can lead to the engine control belt tearing or jumping. This automatically results in engine damage. The coolant pump should be renewed at the slightest signs of a noise and every time the control belt is replaced. Remember that impellers which have become loose from the pump shaft can often be the reason for thermal problems. Noise does not always occur.
