BMW 7 Series (E38) Model year 11.1994 to 11.1995 All vehicles with automatic air conditioning

Failure of the control panel

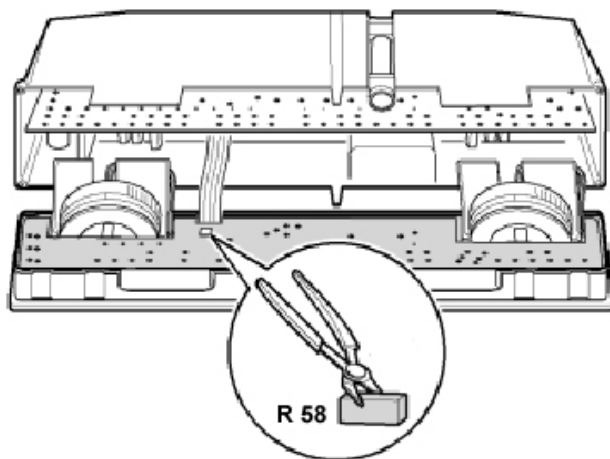
If there are complaints about the above-mentioned fault, the cause could be a resistor in the control panel. Due to incorrect placement, the circuit board was fitted with an additional resistor. The control panel may not fail completely. Sometimes, only the display functions (meaningless displays or no display) in the display are affected. In order for the control panel to work properly again, the resistor (R58) must be removed from the circuit board (see illustration). Due to the fact that special tools are needed for this work, the control panel should be removed and brought for repair to the manufacturer.
