BMW E36 with climate control

Flickering display of the climate control panel.

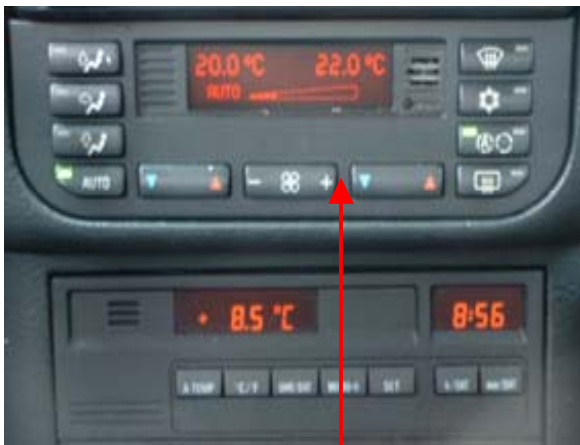
Climate control panel

If on this vehicle model the customer complains a flickering display of the climate control panel, a possible cause could be the instrument panel illumination control. If the instrument panel illumination is switched to the highest level, the display could start to flicker. If the flickering stops, when the instrument panel illumination is switched to a lower level, the instrument panel illumination control must be renewed.

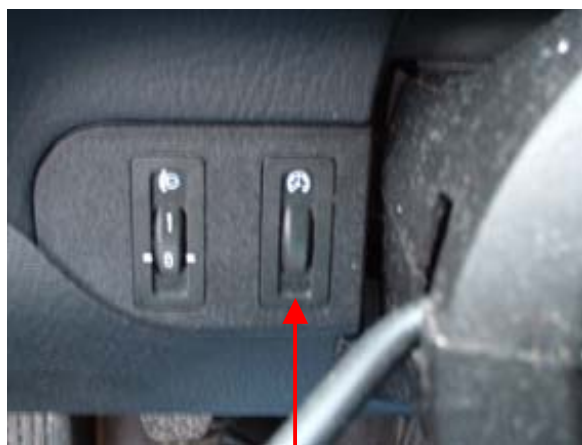
Instrument panel illumination control
