BMW E46 with climate control

LED in the climate button flashes after renewal the control panel

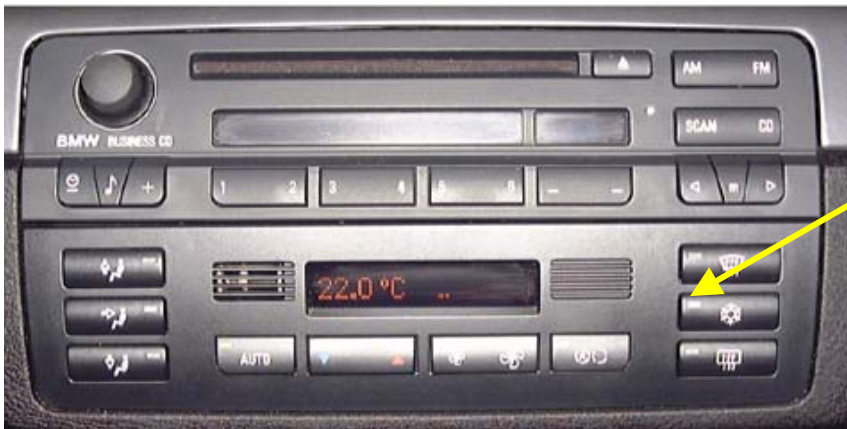
On these vehicles (with climate control) it is possible that the LED in the a/c button flashes after renewal of the control panel. This indicates, that the air-conditioning system is locked in the compressor protection mode. As the spare part is identical with the series part, the LED (see picture) flashes so long, until the compressor has run for approx. 90 seconds at an engine speed of under 1500 rpm.

This ensures that the refrigerant is spread throughout the system before the engine is revved higher. This happens with new vehicles, through the renewal of the control panel this function is repeated as if it were a new vehicle.
