## **Citroen C5**

**Model year 2004 ⇒**

**All vehicles with HDI engines and air-conditioning system**

**Coolant control lamp illuminates**

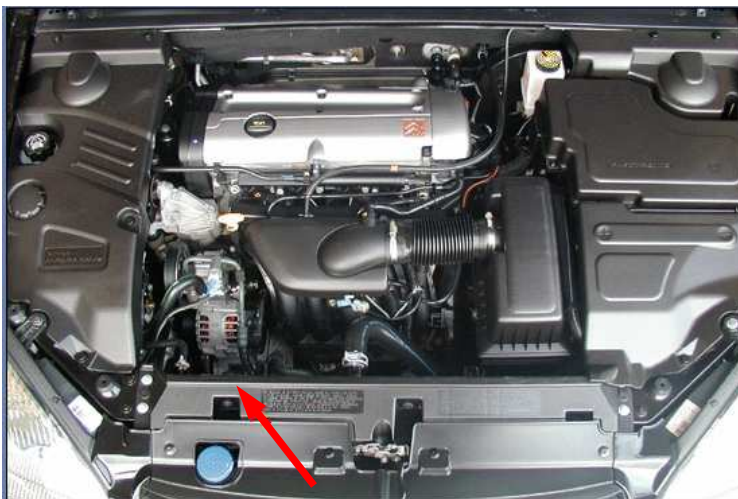
If there are complaints about the above-mentioned fault, the cause could be defective radiator fan relays. Furthermore, it may be that the coolant control lamp illuminates, but the temperature gauge in the cockpit indicates a normal value. In addition, there may also be complaints that when switching on the air-conditioning system the coolant control lamp illuminates. In this case, the three radiator fan relays must be checked and, if necessary, replaced. These are located at the lock carrier below the plastic cover (see illustration.)
