Daewoo

Lanos up to model year 2001

Faults in the engine electronics

Bulletin

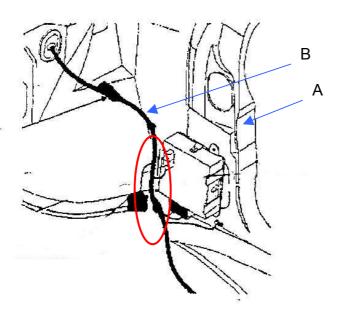
In the case of the above-mentioned model, various faults can occur in the engine electronics. Before apparently faulty components are replaced, these must be examined thoroughly. Particular attention must be paid to the engine wiring harness (illustration, pos. B) near the right-hand A-pillar (illustration, pos. A). There may be breaks in the wiring in the area marked on the illustration.
