Bulletin

FIAT 500 | Bravo | Grande Punto | Panda Engine: Petrol

Explosive hazard and unit damage through connection of the A/C service unit to the fuel system

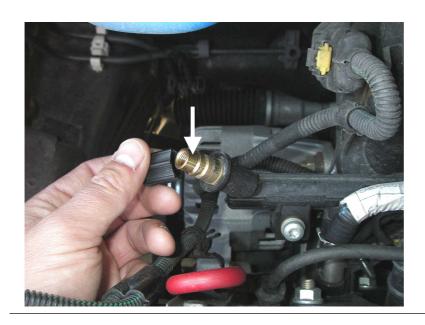
More recent Fiat models have a service connection at the fuel injection system (see photo). Its dimensions and shape are identical to one of the service connections of the A/C system. If the A/C service unit is connected to the injection system connection by mistake during maintenance and repair work,

system and unit damage can occur. The attempt to extract or refill refrigerant via this connection could lead to an explosion. Please bear this information in mind when carrying out service work on all current Fiat models.
