Fiat Punto (188) all models with air conditioning

Ingress of condensation water into the passenger compartment.

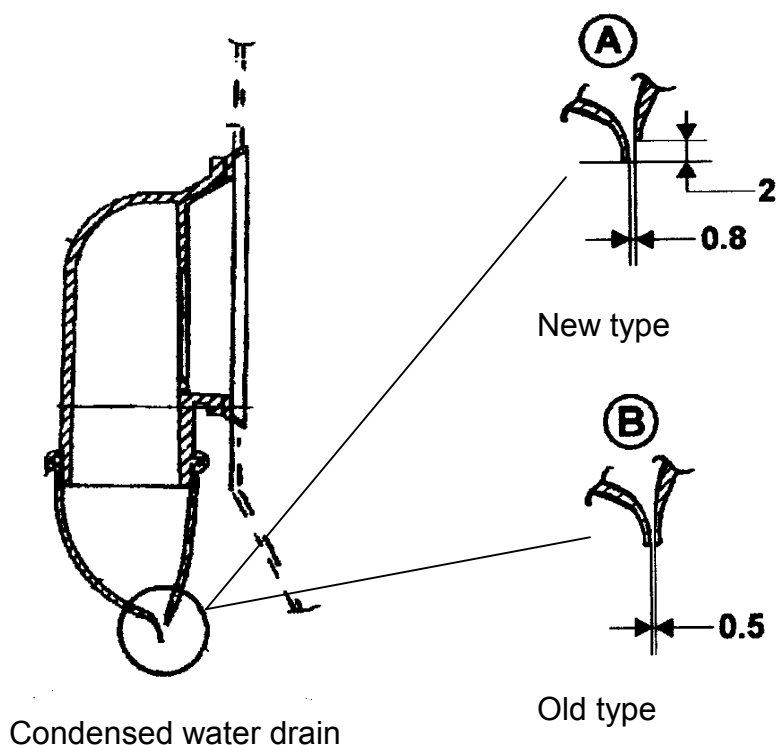
If, on this vehicle, the complaint is that condensation water ingress into the passenger compartment, a possible cause could be a blocked condense water drain.

To rectify the problem, the condense water drain on the fire wall must be renewed. The new condense water drain has the same part number as the original. The difference between the old and new one is the form (see drawings below).

Please compare the new with the old condense water drain before fitting to be sure that the problem does not recur.
