Ford Cougar

Windscreen air vent becomes loose, air flow is diverted.

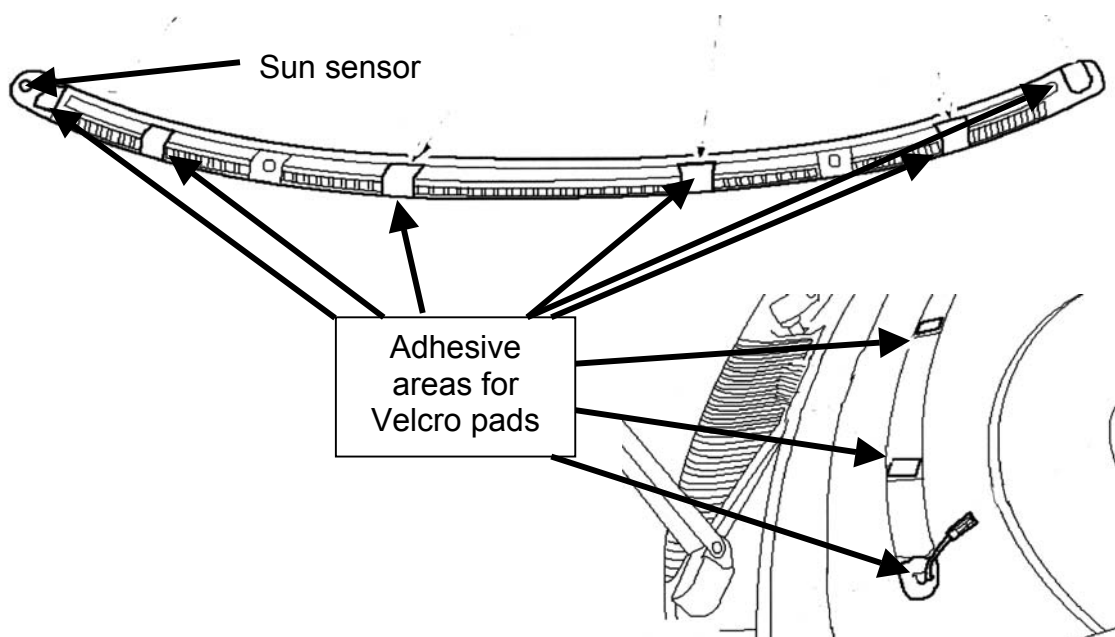
If there are complaints with these vehicles that the lateral ends of the windscreen air vent become loose, one possible cause is a distorted air vent. To eliminate the problem, the air vent must be removed and fitted with new self-adhesive Velcro pads. To do this proceed as follows:

- Unclip the windscreen air vent and remove it.
- Separate the connector from the sun sensor.
- Attach new self-adhesive Velcro pads (approx. 2.5 x 2.5 cm) to the rear side of the air vent and the dashboard (see illustration)
- Cut out the Velcro pad in the area of the sun sensor.
- Connect the sun sensor connector, clip the air vent in place again and press the Velcro pads against one another.
