## **Ford Mondeo Model year: from 05.2002**

### **Low-pressure service connection**

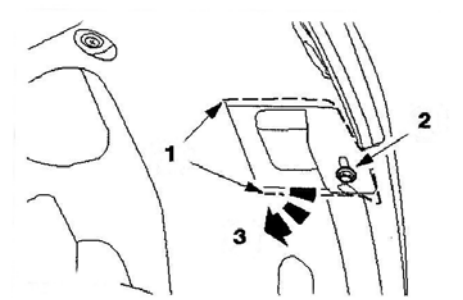
The modified wheel house lining has a pre-marked maintenance opening through which the service connection is accessible. When the service unit is connected to the low-pressure side for the first time, the maintenance opening must be cut in along the marking. Please proceed as follows:

- Lift the vehicle
- Cut in the wheel house lining carefully along the marked lines (drawing, pos. 1)
- Remove the screw (drawing, pos. 2)
- Open the maintenance opening (drawing, pos. 3)
- Once the maintenance work has been completed, close the opening and screw in the screw.
