## ***Ford Mondeo II with TD engine***

### **Bulb replacement, left-hand headlamp**

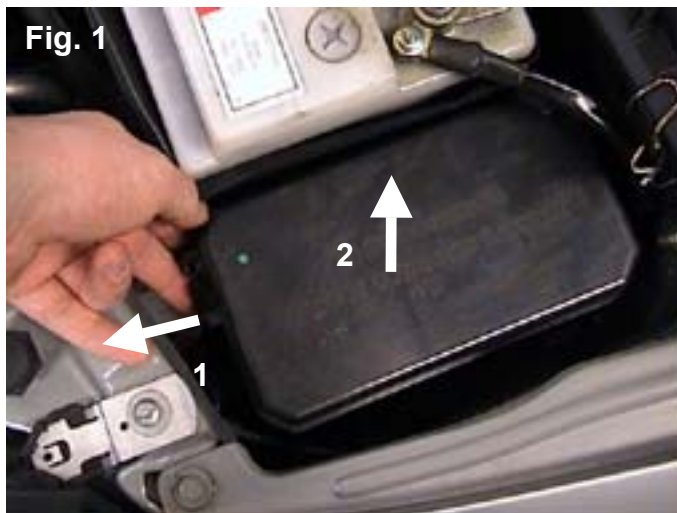
1. Note the radio code
2. Remove the cover cap from the fuse box (Fig.1). Pull the safety clip forwards (1) and then lift the cover off (2)

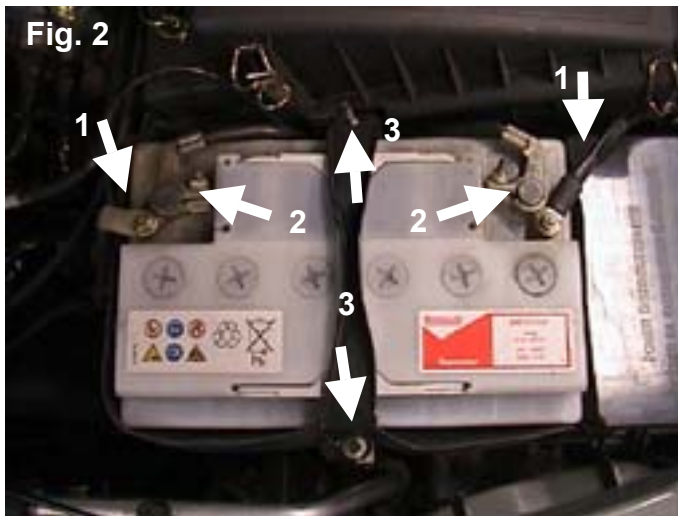
3. Undo the auxiliary cable (Fig. 2) from the battery terminal clamps (1)
4. Loosen the battery terminal clamps and then pull them off the battery terminals (2)
5. Unscrew the nuts which secure the battery (3)
6. Remove the battery from the support bracket

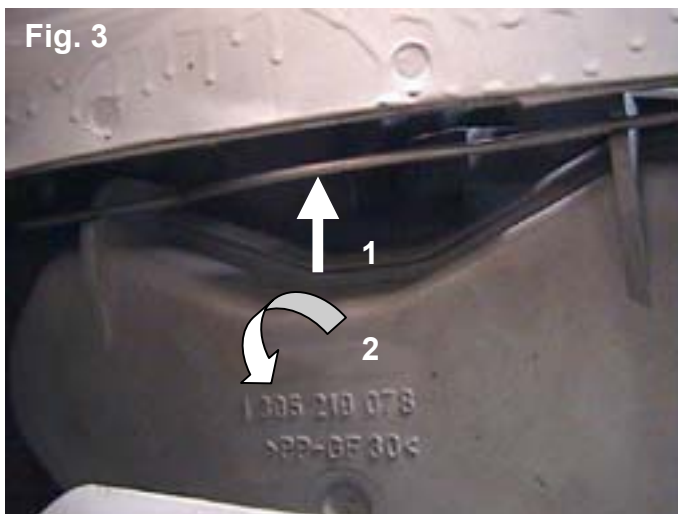
7. Press the retaining clasp (Fig. 3) upwards (1) and remove the headlamp cover (2)

8. Having replaced the bulb, carry out all the steps in the reverse order
9. Enter the radio code again and check that the radio is working
