Mercedes Benz C-Class (W 202) all models

Noise from the fan in the passenger compartment

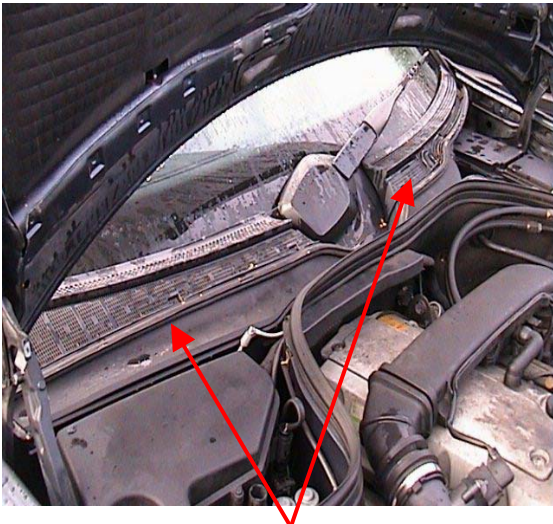
Covers / Pollen filter

If there are complaints about noise from the blower in the passenger compartment with this vehicle type, this can have been caused by the following: soiling of the air intake ducting in the engine compartment and the fan by debris fallen.

- Dismantle the cover of the air intake on the right and left as well as the pollen filter.
- Remove debris and other soiling.
- Remove the fan in the passenger compartment in the footwell on the front passenger side.
- Clean the fan and the air ducting.
- Replace the components in the reverse order.
