BULLETIN

MINI

R50/R53

Failure of the Radiator Fan

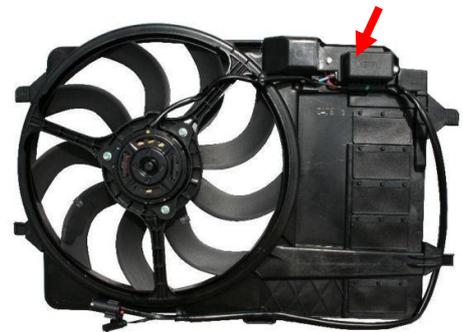
Fig. 1

The fan resistor is mounted to the fan shroud (Fig. 1). The manufacturer of the vehicle does not offer the resistor as a single spare part, but only in conjunction with the fan and shroud assembly. Independent aftermarket retailers do offer the resistor as a single spare part, however (Fig. 2).

Before installing, you should check to ensure that the fan motor is fully functional, does not have any bearing play and/or does not make any odd noises. The technical information provided by the parts supplier for the new resistor must be read and observed. To facilitate installation, we recommend that you remove the fan shroud together with the fan.
