Opel Omega B 2000-2002 with automatic A/C

Windscreen mists up after starting the car

Bulletin

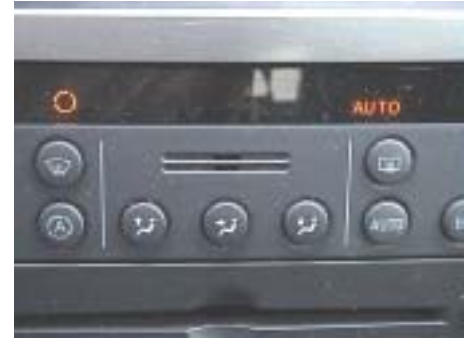
If the inside of the windscreen mists up after starting the car at low outside temperatures, the cause could be a voltage drop. At outside temperatures of -5°C or lower and an under charged battery, a voltage drop under 9 V can occur, due to this the air circulation flap closes suddenly. The failure can be identified by manual operating the air circulation function. After activation of the air circulation, the windscreen demists.

To rectify the fault proceed as follows:

- Check and charge the battery or replace the battery, so that the fault does not recur.
- Press the button „AUTO”
- Switch on the manual air circulation by pressing the button A (in the display three round arrows appear without the A in the middle). The automatic A/C recognizes the right flap position.
- Turn off the manual air circulation after 1 to 2 seconds by pressing the button A.
