Opel Zafira B Model year: 2005 - 2010 Engine: 1.7 CDTi + 1.9 CDTi

Loss of coolant

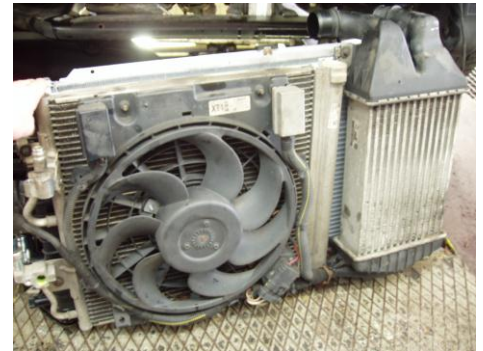
Figure 1

In the above vehicles with small charge air coolers (Figure 1), the charge air cooler bracket can rub on the radiator and cause coolant loss (Figure 2).

When installing a new radiator, the charge air cooler bracket must be mounted so that new damage to the radiator can be ruled out.
