## **Opel Zafira B Model year: from 2005 - Engine: Z19DT, Z19DTH, Z19DTL**

### **Noises / alternator free-wheeling clutch**

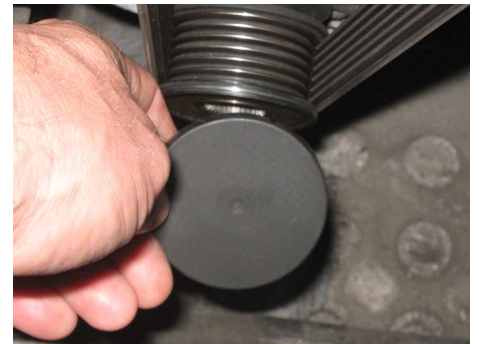
A missing or faulty protective cap on the belt pulley with the free-wheeling clutch results in premature wear. This problem mostly makes itself apparent with noises (caused by the faulty bearing in the free-wheeling clutch). To rectify the problem, the free-wheeling clutch with the belt pulley or, if necessary, the alternator should be replaced.

The figure shows examples of the protective cap and free-wheeling clutch.

Note: on fitting the alternator it is imperative you ensure the protective cap is present. This item is also available separately from the vehicle manufacturer under item no. 93167817.
