## ***Radiator installation note***

**This TI relates to radiators which are fitted to vehicles of the series BMW E30, E36, E34 and E39**

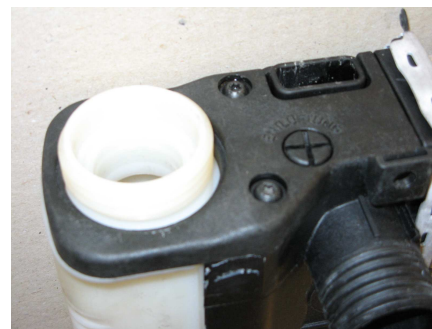
After the radiator has been replaced, the cooling system is filled with coolant mixture via the integrated expansion tank according to the vehicle manufacturer's instructions and bled using the bleeding screw. In the course of this, fluid automatically escapes via the bleeding screw, and spillage automatically occurs during the filling process.

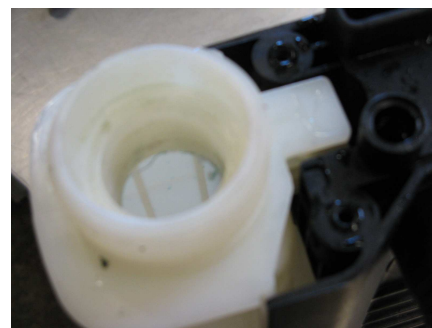
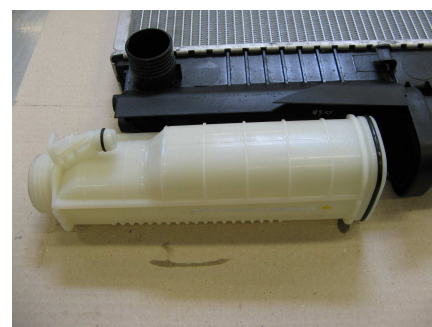
Since the expansion tank is installed in the radiator as a separate component, there is a recess behind it where part of the liquid can collect. This can drain off through an opening on the base of the tank.

In the case of a brief examination, the impression may be gained that the radiator is leaky and fluid is escaping from the radiator.

After purging by means of compressed air, the remaining fluid evaporates when the engine warms up.

In order to prevent unjustified complaints, please observe the procedure.
