## **Renault Laguna (B56, K56)** **With semi or fully automatic temperature control**

### **Functional failure /** **"Service" and "Temp" light up**

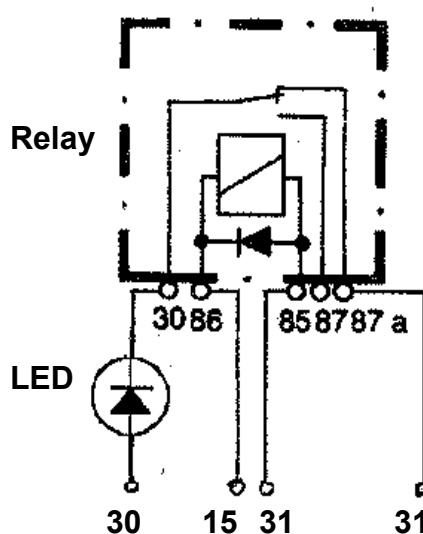
If the air conditioning function should fail with the above-mentioned vehicles and/or the "Service" and "Temp" lamps light up on the air conditioning control unit when starting the vehicle, a false connection of the alarm system LED can be the cause. The fault "micro-motor", "air recirculating" and/or "air distribution" can be stored. Before replacing any components the correct connection of the LED "alarm system" should always be checked. The LED must not be connected between +AVC (30) and +APC (15). Otherwise the LED must be disconnected and reconnected as follows with the aid of a Hella changeover relay (e.g. Hella part no.: 4RD007794-041) (pin 87 is not occupied):
