## **Bulletin**

## Rover 75

# Querying the fault memory via the control unit

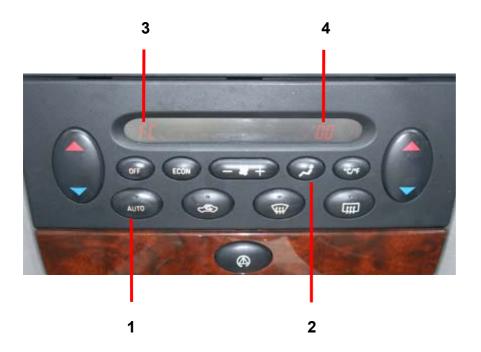
- Switch off the ignition
- Press the "Auto" button (photo, pos. 1) and keep it pressed
- Press the button for air distribution (photo, pos. 2) and keep it pressed
- Switch on the ignition (a warning sound will be heard)
- Display for air conditioning/heating flashes
- Release buttons
- After a short time the display will change to diagnosis mode
- The letters "FC" will appear on the left of the display (photo, pos. 3), the two-digit fault code will appear on the right (photo, pos. 4) (see table below)
- If there are several codes in the memory, these will be shown in succession

Fault code	Possible fault
00	No fault found
11	Interior temperature sensor
12	Outside temperature signal
13	Evaporator temperature sensor
14	Heat exchanger temperature sensor
21	Sunlight sensor left output signal
22	Sunlight sensor right output signal
31	Blend air flap motor left
32	Blend air flap motor right
33	Air distribution motor
