Saab 9-3

Vehicle locks and unlocks on its own, engine cannot be started.

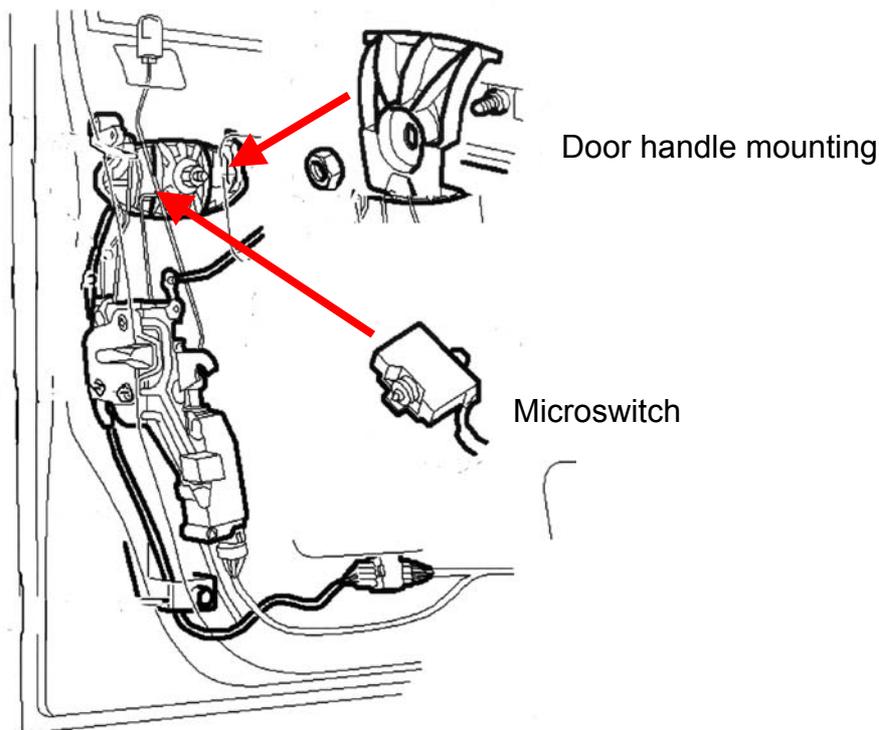
If there are complaints with these vehicles that the central locking locks or unlocks of its own accord and that the engine cannot be started, one possible cause is a damaged cable. This cable is for the microswitch on the front door handle (see drawing). The cable may be trapped between the handle and the mounting bracket. The damage leads to faults in the central locking and the alarm system. To rectify the fault, the door handle must be removed, and the cable for the microswitch must be checked for damage. If the cable is damaged, the entire door handle including the microswitch should be replaced.
