Saab 900 **build year 1994 - 1995** **with climate control**

Discharged battery

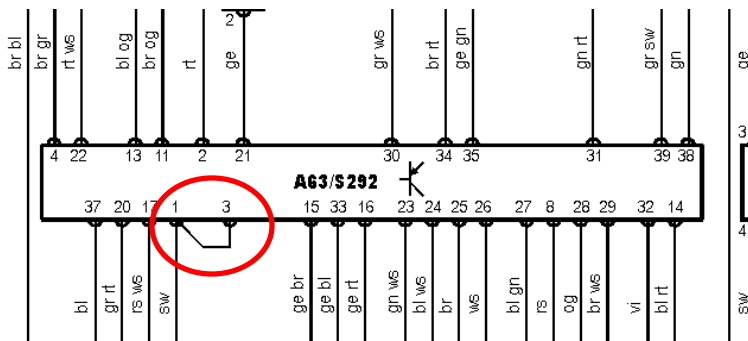
One cause of a complaint for a recurring discharged battery can be a permanently running fan for the interior temperature sensor. The fan should automatically switch off at most, five minutes after the ignition has been switched off. If the fan continues to run, the problem is caused by the A/C control unit. To remedy this, please proceed as follows:

1. Remove the A/C control unit
2. Disconnect the plug from the control unit
3. Construct a bridging cable from pin 1 (black cable, ground) to pin 3 into the connector housing – see pic. (only if pin 3 is vacant – from 1995 already fitted from factory)
4. Connect the plug to the control unit
5. Install the control unit
6. Carry out a function test
