Bulletin

Seat Alhambra, build year 06/2000

Air conditioning functionless, slow loss of refrigerant.

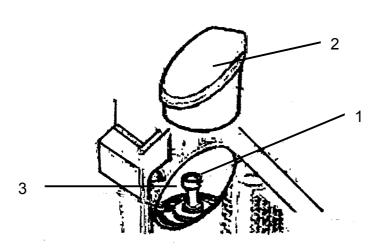
If on this vehicle the air conditioning is functionless due to missing refrigerant or a slow refrigerant loss is found, a possible cause could be a leaking filter/drier housing. The filter/ drier (1) is integrated with the condenser. The filter/drier housing is sealed by a plastic cap. To check for leaks, consider the following steps:

- Evacuate and charge the air conditioning with the exact charge of refrigerant and run the system for a few minutes.
- Remove the plastic cap (2) of the filter/drier housing (do not remove the snap ring when the system is full).
- Fill the area (3) above the filter/drier cartridge up this water.
- Check for formation of bubbles.
- If a formation of bubbles is found, the condenser must be renewed.
