# Bulletin

## **Skoda Octavia All models with 2.0 TDI engine Engine code BMN From model year April 2006**

Vehicle not starting up.

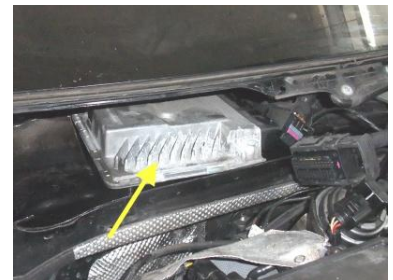
Fig. 1

If this deficiency is detected in connection with the above error codes, it may be caused by a short-circuit in an injection valve (Fig. 1).

This deficiency frequently occurs in vehicles with more than 100,000 km on the clock.

After replacing the defective injection valve you should check that the endstages in the electronic control unit (Fig. 2) are functioning correctly and check the injector cable harness (Fig. 3) for possible cracks or damaged contacts. To avoid further damage, when an injector valve fails it is advisable to check, and if necessary replace, Fig. 2 all the other injector valves that have the same code number, because it can be expected that these may be the next to fail. Please do this by following the disassembly and reassembly instructions from the vehicle manufacturer.
