Skoda Octavia 2.0, from model year '99, engine codes AQY, APK, AZH

Poor start-up behaviour

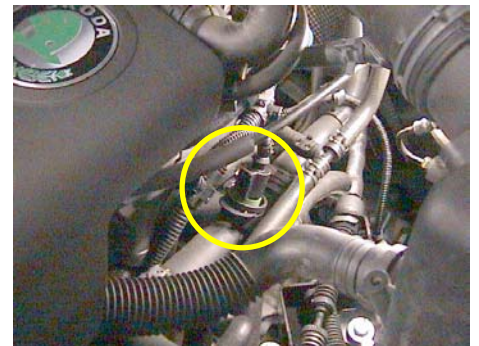
If there are complaints about the above-mentioned fault, the cause could be the coolant temperature sensor.

The fault code 16501 – coolant temperature sensor, may also have been stored in the fault memory.

Reference values at the sensor:

- at + 20 °C engine temperature = 2.50 – 2.67 K Ω
- at + 90 °C engine temperature = 215 – 245 Ω

To replace the sensor, proceed as follows:

- Unscrew and remove the engine cover
- Disconnect the cable plug from the sensor
- Pull out the retention clip forwards
- Remove the sensor with the seal. Since coolant will splash out of the opening, replacement should take place with the engine cold, so as to prevent skin burns
- Insert the new sensor with the new seal
- Refit the components in the reverse order of removal
