Subaru

Failure of the electronic evaporator thermostat

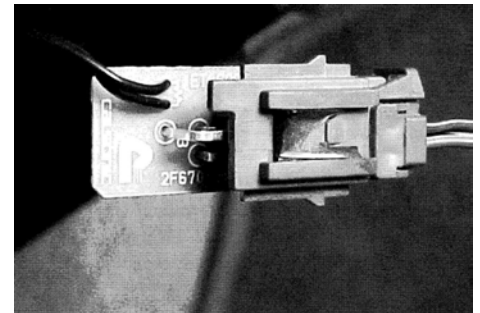
On some Subaru vehicle types a faulty electronic evaporator thermostat with built-on temperature sensor leads to a freezing of the evaporator. This can be noticed by measuring the air outlet temperature at the interior centre vent. If the temperature drops below 0° C, often the cause can be the electronic evaporator thermostat (picture) or the built-on NTC temperature sensor. Thermostat and temperature sensor are only available as a complete spare part.

If the compressor clutch disengages, directly after the a/c has been switched on, and by switching off the a/c and switching it on again the clutch engages again (but only for a short time), the cause can also be due to the electronic thermostat failing.
