Suzuki

Alto

All models: 2002 to 2007

Value displayed on coolant temperature gauge is too low.

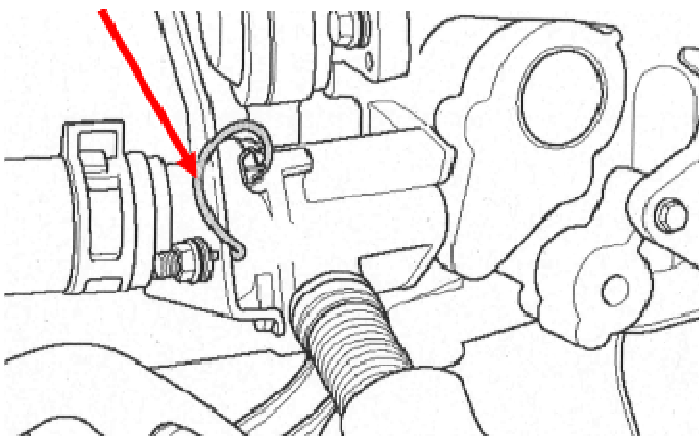
If these vehicles display an irregular coolant temperature value, the possibility of a bad ground connection to the thermostat housing bracket must be considered. To fix this problem, the ground cable (see figure) should be connected between the thermostat housing and the thermostat housing bracket.

Additionally, check the thermostat housing for damage and replace if necessary.

1 unit: Thermostat housing: 17690M79F20

1 unit: Ground cable: 39313M82020

1 unit: Fastening bolt: 02142M05123
